Monitoring the integrity of filament wound structures using built-in sensor networks

Mark Lin^a, Amrita Kumar^a, Xinlin Qing^a, Shawn J. Beard^a, Samuel S. Russell^b, James L. Walker^b,
Thomas K. Delay^b

^aAcellent Technologies, Inc., Sunnyvale, CA 94089

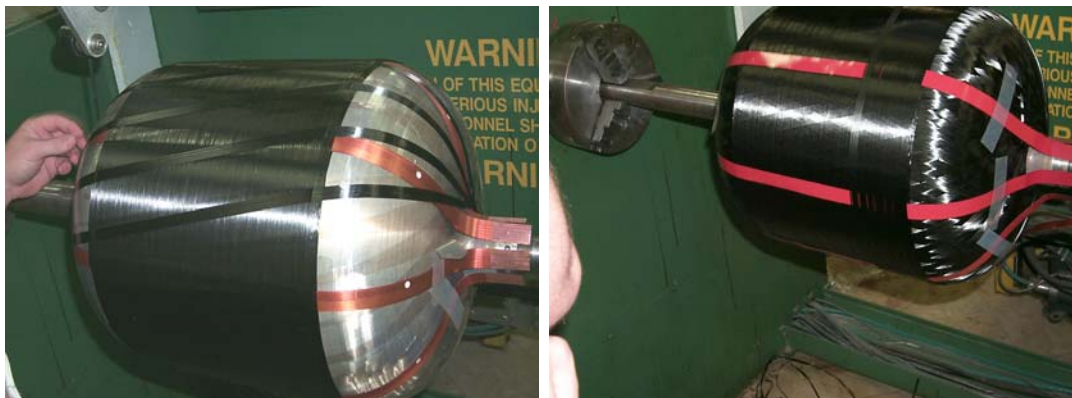
The fabrication of filament wound composite bottle was done at NASA Marshall Space Flight Center's facility. Some pictures showing the filament winding process that incorporates the SMART Layer strips into the bottle are shown in Figure 5. The main process involves winding composite prepreg tows onto an aluminum liner mandrel in either a hoop direction or a helical pattern. First, a hoop layer was wound onto the cylindrical section of the bottle. Four SMART Layer strips were then placed on top of the hoop layer and held in place by Teflon tape affixed on the dome part. Then two hoop layers were wound over the cylindrical section again. Next, the tapes used to fix the location of the four SMART Layer strips were removed before winding two helical layers over the entire bottle. Then, another hoop layer was wound over the cylindrical section. Next, the four outer SMART Layer strips were placed on the bottle, held in place by Teflon tape. Finally, a hoop layer was then wound on top of the cylindrical section, leaving the outer SMART Layer strips exposed on the dome part. All the piezo elements on the SMART Layer strips were oriented towards the thicker side of the composite: the piezos on the inner strips face outward and the piezos on the outer strips face inward. After the filament winding process, the composite bottle was cured at 350°F for 2 hours in an oven. Because the curing process did not use vacuum bagging, Teflon tape was used to hold the four outer SMART Layer strips onto the dome part of the bottle which was later removed after the cure.

Figure 5: Filament winding process incorporating the SMART Layer strips into the bottle.
